# Monet Conservation Project

# Argenteuil Basin with a Single Sailboat

# **Technical Report**

NGI number:	852
Artist:	Claude Monet (1840-1926)
Title:	Argenteuil Basin with a Single Sailboat 1874
Medium/Support:	Oil on canvas
Dimensions:	Unframed: 55 x 65 cm H x W. Framed: 79 4 x 89 5 x 9 7 cm H x W x D

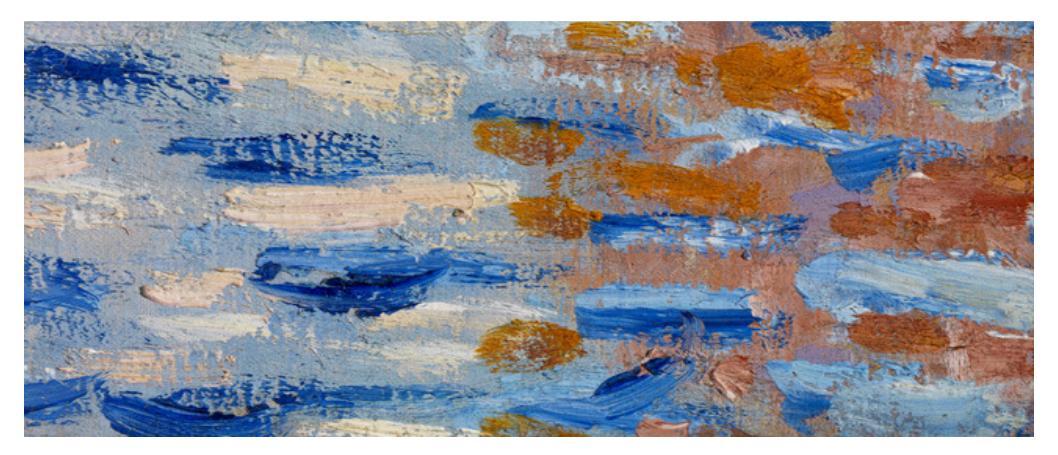
**The Impressionist brushstroke** *(above):* Monet did not use thin glazes to build up shadow and form. Instead, his most striking effects were created using a single colour, quite thickly applied using a bold, flat and even-loaded stroke. This type of brushwork has been given the term *tache*, the French word for 'blot' or 'stain'. The *tache* was the basis of the Impressionist paint-handling technique, and was made possible by the invention of a circular metal clamp or *ferule* which allowed for the production of flat brushes – previous to this, brushes were mainly round in shape. The *tache* technique of paint application signalled a move away from the traditional method of blending colours on the canvas. In the foreground of this painting, ripples across the water and the fall of light are articulated using even and thickly applied taches of blue, orange, and white paint.

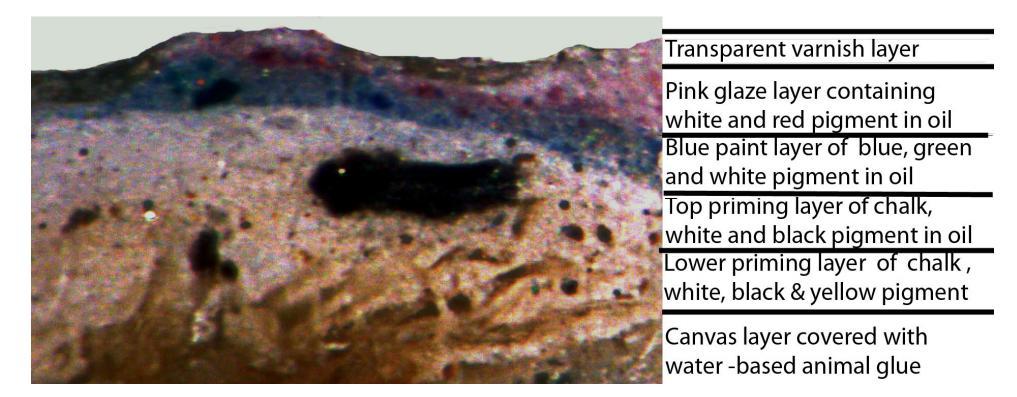
The cross section image above shows the build-up of layers in *Argenteuil Basin with a Single Sailboat*. From the bottom upwards, six distinct material layers can be identified: canvas support with glue size, lower primer, upper primer, paint layer, glaze layer and varnish layer. The glue and priming layers were applied to the canvas by the commercial colourmen who also tacked the canvas onto a wooden stretcher before Monet purchased it.

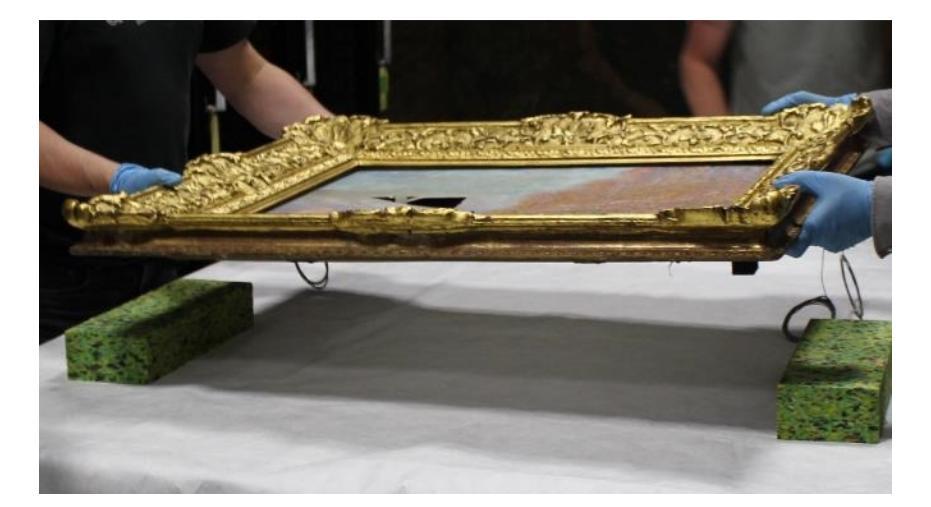
# Stabilising the painting

Before the painting was moved from the exhibition space, conservators examined the painting for signs of loose paint and flaking, temporarily securing any loose fragments. As a result of the impact sustained by the painting, tiny fragments of paint and ground came loose and were deposited on the painting's surface and the ground nearby. These fragments were carefully collected and stored for later reinsertion. The painting was removed from public display and taken into the conservation studio for treatment. It was laid flat and stabilised from the front and back. Conservators removed the painting from its frame and documented any changes to the condition of the object.

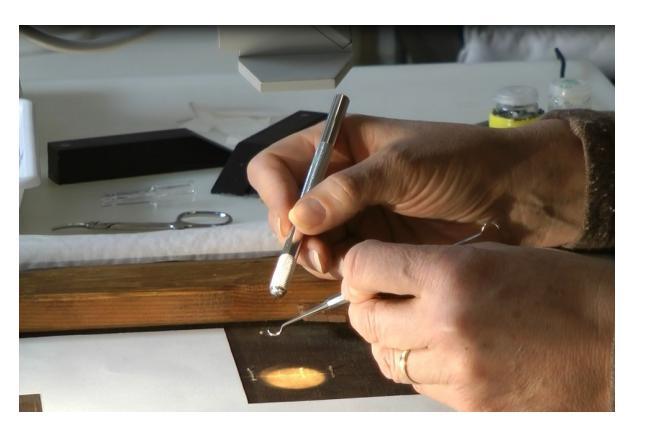
#### **Tear repair**

The canvas support of *Argenteuil Basin with a Single Sailboat* had been locked into a close weave for over 130 years. As a result of the impact sustained, the tear edges were sharp and misaligned. The process of tear

repair involved flattening, aligning and re-joining the edges of the torn canvas. Initially the canvas was relaxed using localised application of moisture and gentle weighting for short intervals – training it to remain flat again. With the aid of a high-powered microscope and appropriately small tools, the tear edges were carefully aligned threadby-thread. Re-joining of the realigned, broken canvas fibres involved applying a specially formulated adhesive to achieve a strong but reversible bond between the thread ends. This adhesive material has been used and developed by painting conservators in Germany over the past 40 years.

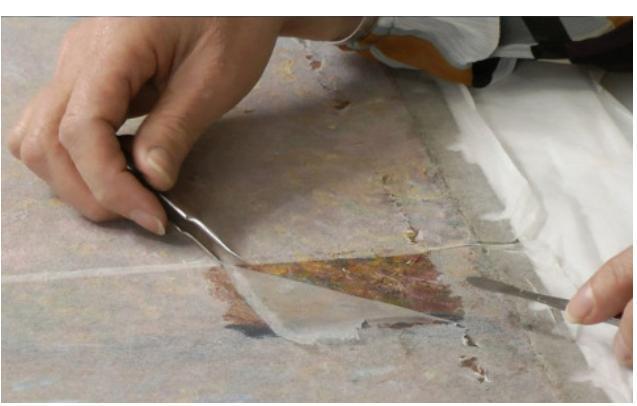
#### Removing the protective facing

moisture. The painting has a modern glossy varnish layer which was not applied by the artist. This synthetic varnish had greyed due to the build-up of particulate dirt on the surface. Aesthetically it would have been ideal to remove this varnish, to recover the matte surface, probably left unvarnished by Monet. Due to the sensitivity of the pigments, however, National Gallery conservators decided not to remove the varnish. Instead, a surface clean was performed by removing the dirt embedded in the top of the varnish while removing the facing. This shifted the tone of the painting towards a brighter and lighter appearance, bringing the colours closer to how they may have originally looked.

Once the tears had been re-joined, it was possible to return the painting to a face-up position. At this point the protective facing tissue and adhesive could be removed from the paint surface using a small amount of
